**MVS question**

I have an MVS wastegate on my '99 Eclipse that I use for HPDE track days. I initially ran it without water cooling and ruined the diaphragm quickly, so I started water cooling it. Since then, I've constantly had the water fittings loosen up slightly and start leaking. I have plenty of venting in my hood so I can start to see the water misting on the windshield when they've loosened. I tried blue loctite, red loctite, and I recently tried JB-welding the fittings in place (on the outside, not the threads) which worked for a few sessions but then failed again since it couldn't handle the heat. The last time I went to reseal the fittings, the threads in the wastegate actually stripped out completely. At this point I'm considering purchasing aluminum fittings to weld in the holes. Short of that, do you have any other suggestions for how to keep the fittings from loosening? If I don't weld the fittings, I'll have to get a new lower housing anyway due to the stripped threads.

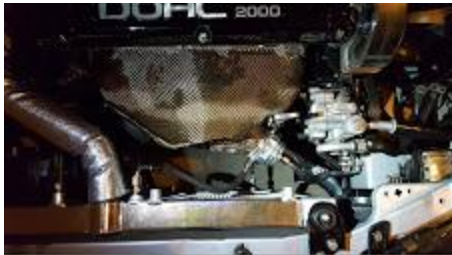
Thanks for the photos, as this is helpful. Since it appears you're using flexible -AN lines, this should help with any vibration, but the one thing I cannot see could be a factor.

Since the coolant port threads are only M8x1.0, that's likely the weakest link if vibration is an issue. I've also noticed that on high-vibration applications, the original aluminum washers that we provide with the MV Series can be damaged more easily than, say, copper or bonded-steel washers. One specific Motorsport team actually uses a bonded washer (sometimes called a 'dowty seal') and they've reported that it works very well, and that engine fights a terrible vibration signal.

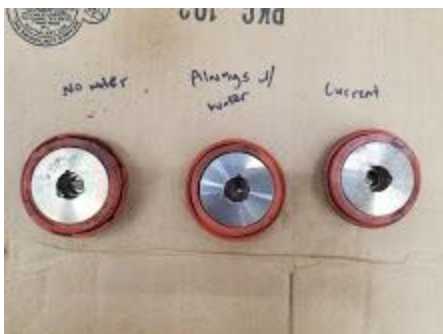
20210707\_164244.jpg  
3255K

You mentioned that the housing had been run without coolant for a bit of time, and that resulted in a diaphragm (and likely a lower actuator housing o-ring) failure. If the lower housing was subject to enough of a temperature increase to allow damage to those 'soft' parts, it could also have affected the actual aluminum material. A deep-dive into the characteristics of 6061-T6AL is probably not necessary here, but I can tell you that we've tested these effects on our gas test stand, and there's a video on our server that shows two heat sources applied to a working wastegate actuator (the valve temp is held at 1950degF) to monitor the effects of heat from both the lower valve casting and from radiant sources typically found in the engine compartment.

From that testing, we know, for example, that the anodized finish (if applicable) will begin to fade at around 350degF, and the diaphragm and lower o-ring seal, both of which are rated for 425degF, will begin to fail shortly after. The actual aluminum will not 'melt' until ~650degF, but it will begin to anneal (soften) at a lower temperature rate, and this could be the case; the metal could simply have become fatigued. I have seen units returned for inspection that had no coolant flow, and the diaphragm and lower seal were 'powdered' due to heat, and the lower housings were notably fatigued.

I have had the wastegate apart a few times replacing and inspecting diaphragms. I know in the past I've had the o-ring in place, but I just went to double check and it's not there. I don't think it fell out on my shop floor and it's not stuck to the bottom of the lower housing. I don't see any gooey remnants of a melted o-ring so I guess there's the potential it wasn't in there, I'm not sure what this would lead to. The diaphragm was a little more charred than in the past this time opening it, but I did run three 20-minute sessions without the water once the threads stripped out. It's getting replaced with an older decent spare I have.

Those pictures certainly do tell the story, don't they? I'm going to hang on to those photos to show the value of the coolant flow, if you don't mind. For what it's worth, the damage to the left-hand photo is consistent with what we see at 450+degF during testing.

I'm happy to include some spare o-rings with that lower housing. These are SAE 015 rings, but we do use a flourosilicon (FKM) material for the higher temperatures. When installing that, use a dab of silicon o-ring lube, and try to avoid using petroleum products near that o-ring or around the diaphragm, as they're technically solvents and can harm the material.

I will also send new screws and some extra M8 aluminum washers. When you install that lower housing, use Loctite 271 or 272 (red and red/hi-temp, respectively), as those higher temps probably cooked that original application, and you don't want those to come loose. For the diaphragm set screws, use Loctite 242 (blue) for both locking and sealing.
